NASA TN D-7703

FLIGHT EVALUATION OF ADVANCED
CONTROL SYSTEMS AND DISPLAYS
ON A GENERAL AVIATION AIRPLANE

*by Paul C. Loschke, Marvin R. Barber,
Einar K. Enevoldson, and Thomas C. McMurtry*

*Flight Research Center
Edwards, Calif. 93523*

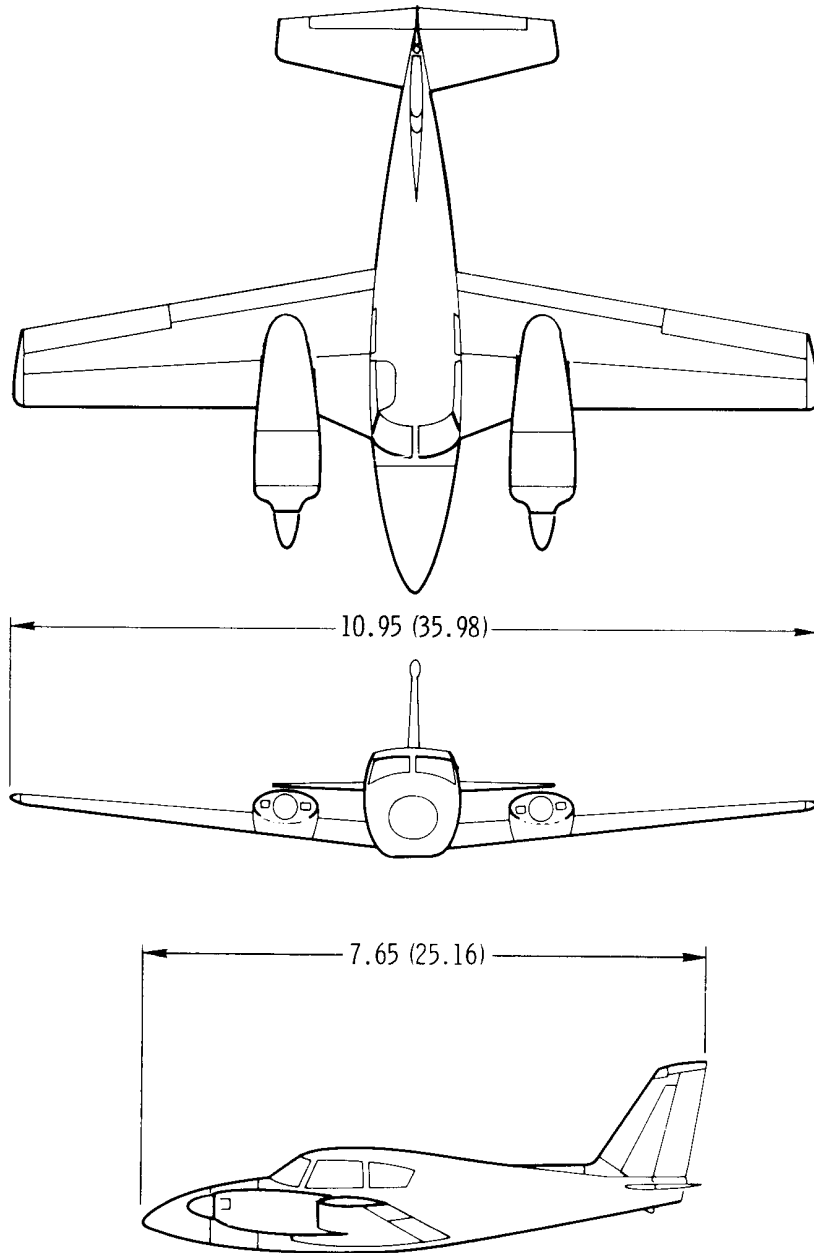
Figure 1. Three-view drawing of test airplane.
Dimensions are in meters (feet) .

The systems evaluated were tested in the airplane shown in figure 1. The airplane was a six-place, low-winged, twin-engined airplane that is representative of privately owned general aviation aircraft. Control was provided by conventional control surfaces. An all-movable horizontal stabilator with a geared antiservo tab provided longitudinal control. The stabilator could be deflected 4° trailing edge down and 14° trailing edge up. Both ailerons could be deflected 14° down and 18° up, and the rudder could be deflected $\pm 27^\circ$. The airplane was equipped with both mechanical and electrical longitudinal trim systems. Directional trim was provided by a mechanical bungee system.

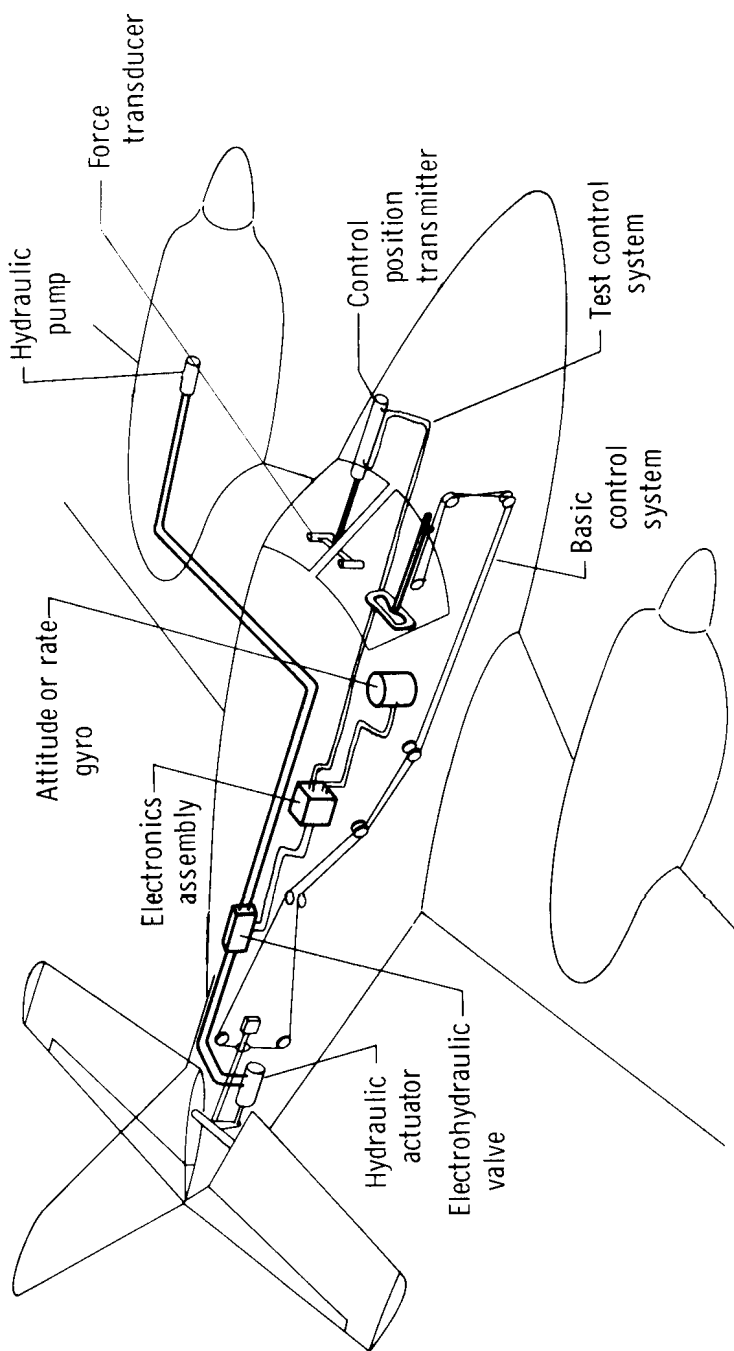
Figure 2. Test control system mechanization in pitch axis.

to the safety pilot (right controls). Since the actuators were connected in parallel with the mechanical control system, differential pressure across the actuators had to be relieved before the safety pilot could move the control surfaces freely. Therefore, redundancy was designed into the actuator depressurizing function to provide fail-safe control transfer. Figure 3 shows a schematic drawing of the servoactuator and hydraulic manifold that were used for all three control surfaces. The figure illustrates two methods for relieving pressure in the actuator.

The first method was through a solenoid valve, which was normally open. In the event of an electrical power failure, the solenoid valve dropped open and fluid passed through the valve. In addition, the solenoid valve opened automatically when preset levels of aircraft normal acceleration, angular rates, and control surface rates were exceeded. This insured the immediate transfer of control from the hydraulic controls to the safety pilot's controls if a failure induced a surface hard-over. The safety pilot could also deenergize the solenoid valve with a manual disconnect switch on his control wheel.

Pressure in the actuator could also be released through pressure relief valves connected in parallel with the actuator. If the solenoid valve malfunctioned, the safety pilot could exert override forces on the right controls to raise the relief valve. The relief valves opened at preset relief pressures and were installed so that pressure could be relieved from either end of the actuator. In selecting the relief pressure levels for each control axis, an attempt was made to minimize the override force for the safety pilot while maintaining an acceptable level of hinge-moment capability. If the relief pressure levels were set too low, the relief valves limited the available hinge moments and reduced the response capabilities of the actuators. The override forces chosen were ± 178 N (± 40 lb) for pitch, ± 134 N (± 30 lb) for roll, and ± 445 N (± 100 lb) for yaw.

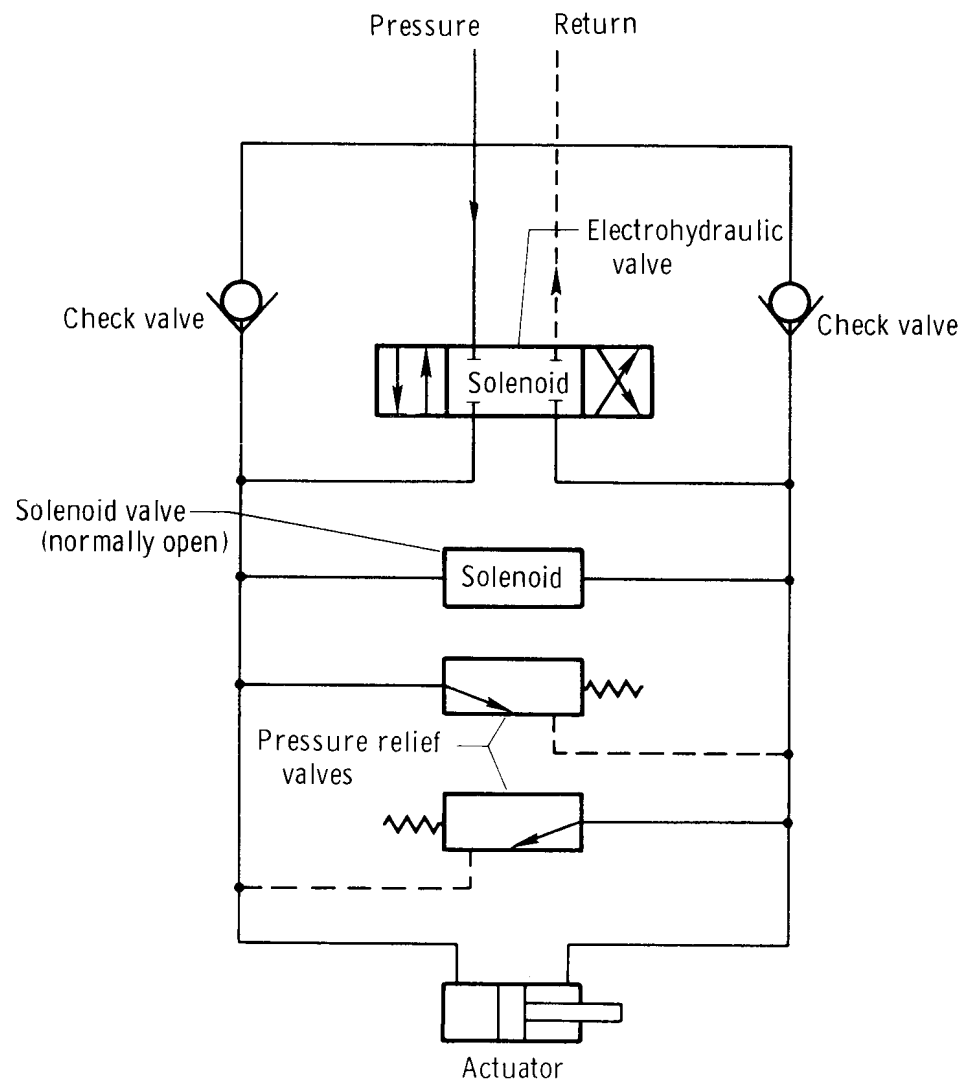
Figure 3. Servoactuator and hydraulic manifold.

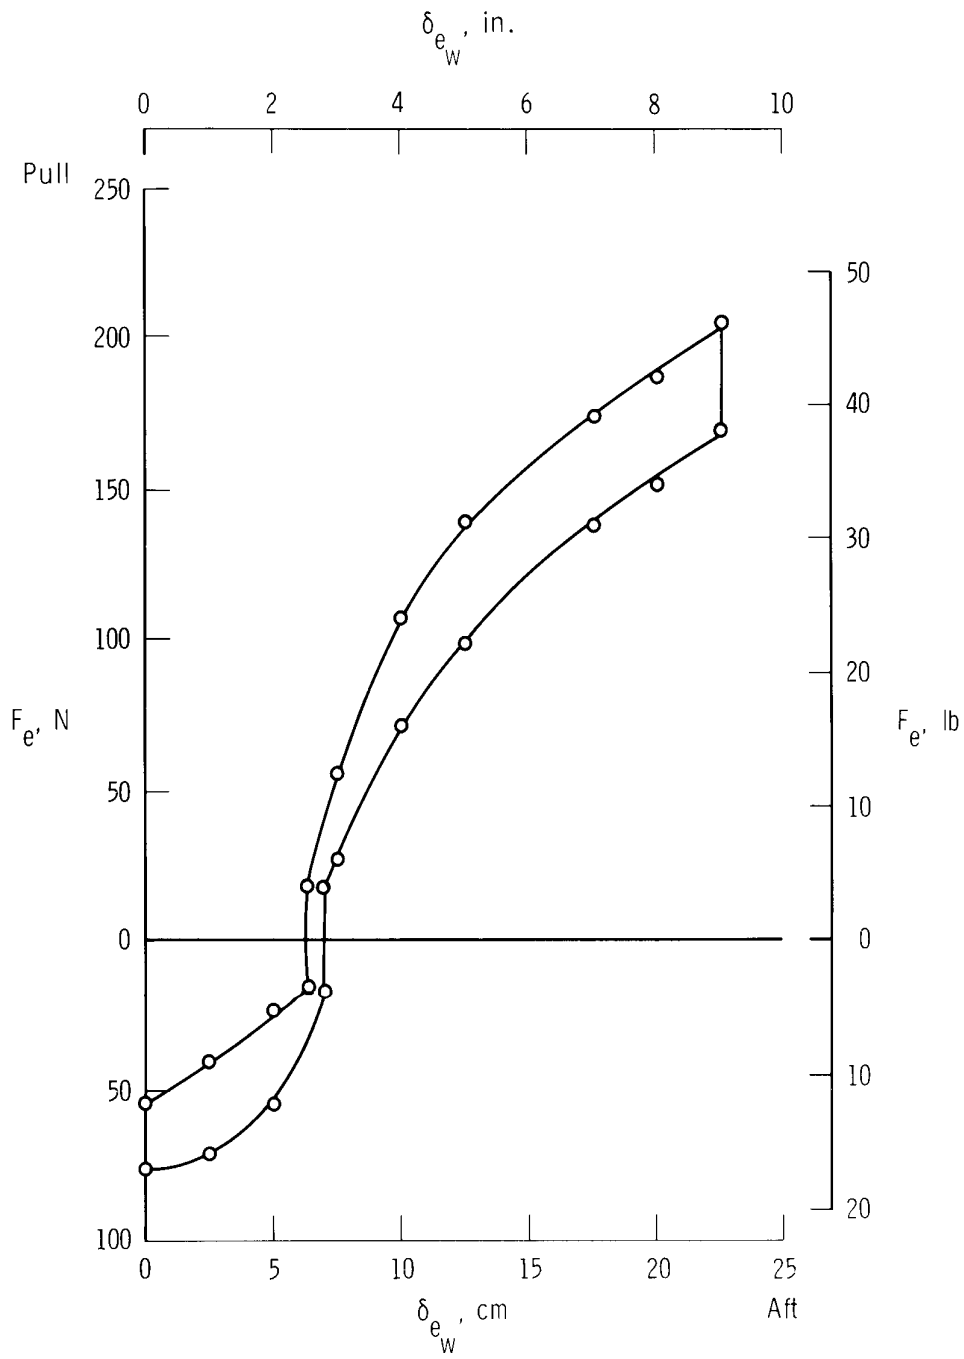
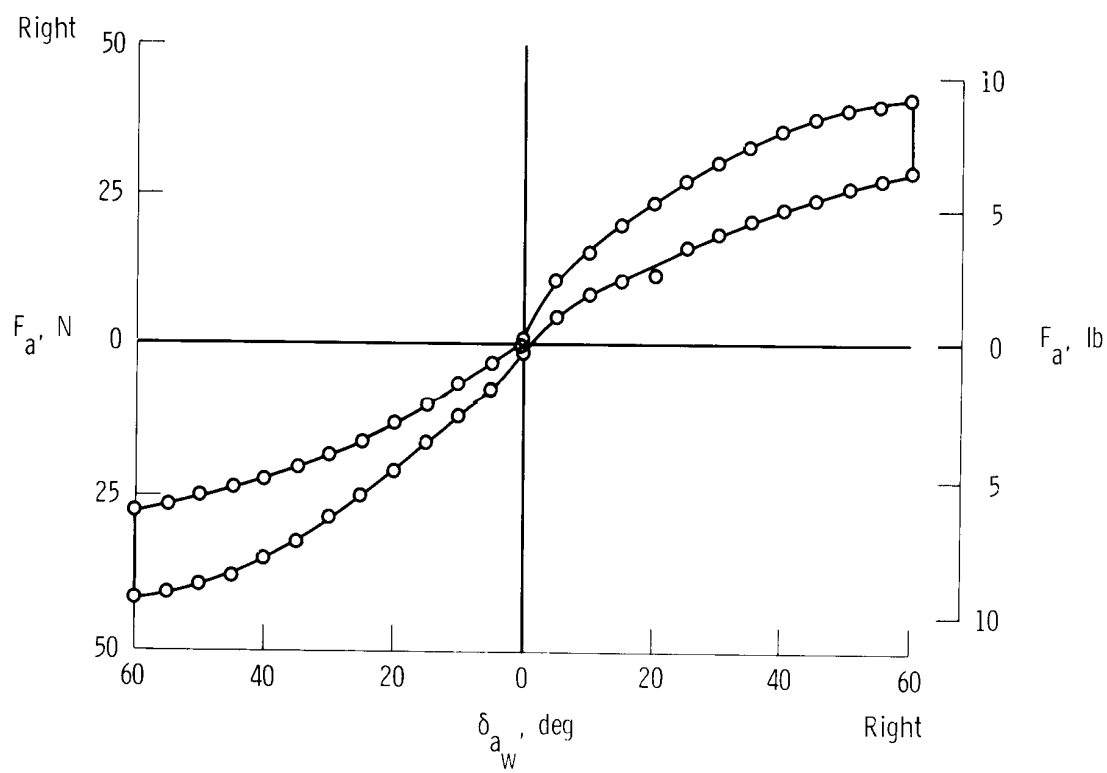
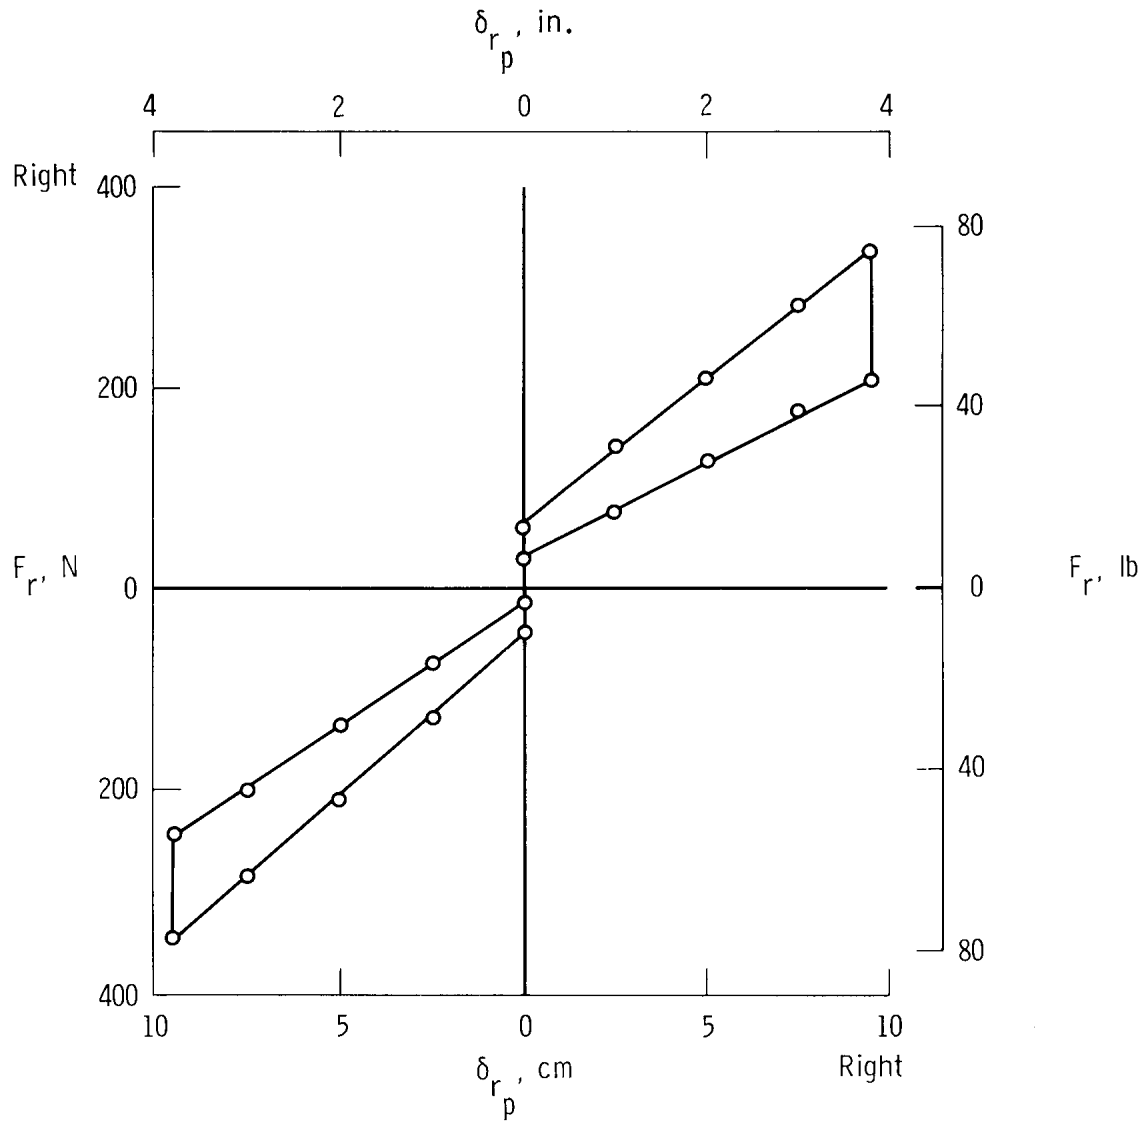
(a) Elevator.

Figure 4. Artificial-feel bungee characteristics.

(b) Aileron.

(c) Rudder.

The artificial-feel bungees were adjusted to approximate the force characteristics of the conventional controls during a 100-knot approach flight condition. Figures 4(a)

to 4(c) show the artificial-feel characteristics of the elevator, aileron, and rudder controls, respectively. These characteristics were not varied during the program.

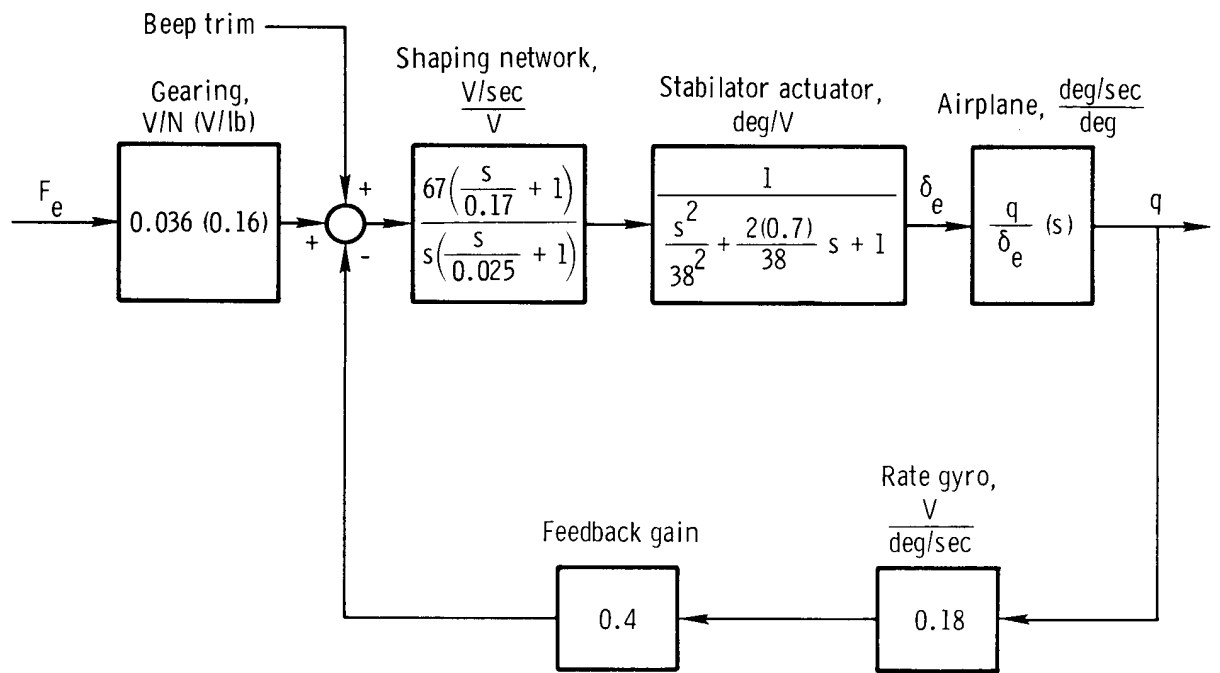
Figure 5. Pitch-rate-command control system .

Figure 5 shows a transfer function block diagram of the pitch-rate-command control system with the gains and shaping used during the ILS approach evaluations. The rate error signal was integrated in the shaping network and fed to the actuator, which drove the stabilator at a precise rate and direction. The result was that the airplane rate equaled the commanded rate. Lag compensation in the shaping network provided closed-loop damping of the phugoid mode, and therefore allowed precise control of pitch rate. The closed-loop natural frequency and damping of the longitudinal short-period mode did not differ significantly from the natural frequency and damping of the unaugmented longitudinal short-period mode.

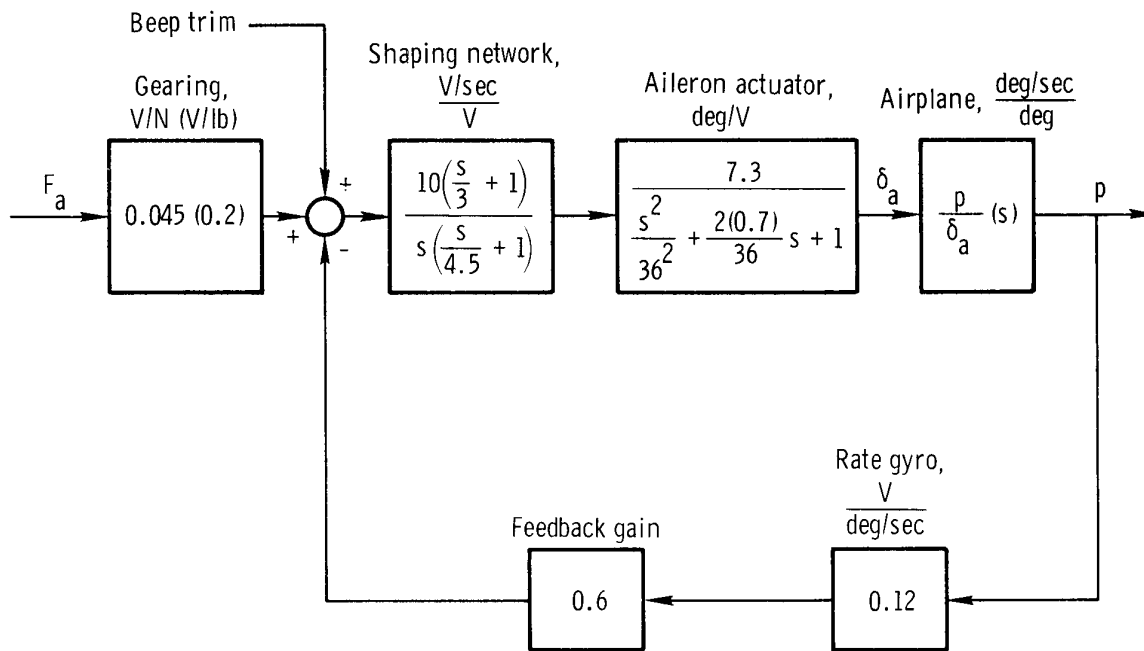
Figure 6. Roll-rate-command control system.

Figure 6 shows a block diagram of the roll-rate-command control system. The gains and compensation shown are representative of the system's configuration during the ILS evaluations. The system was similar in design to the pitch-rate-command control system. The rate error signal was integrated to provide a roll rate equal to the commanded roll rate. The lead compensation in the shaping network provided closed-loop neutral spiral stability and also interacted with the roll mode to provide closed-loop second-order roll-rate response. The second-order roll-rate response had a natural frequency of approximately 1 hertz and a damping ratio of 0.5.

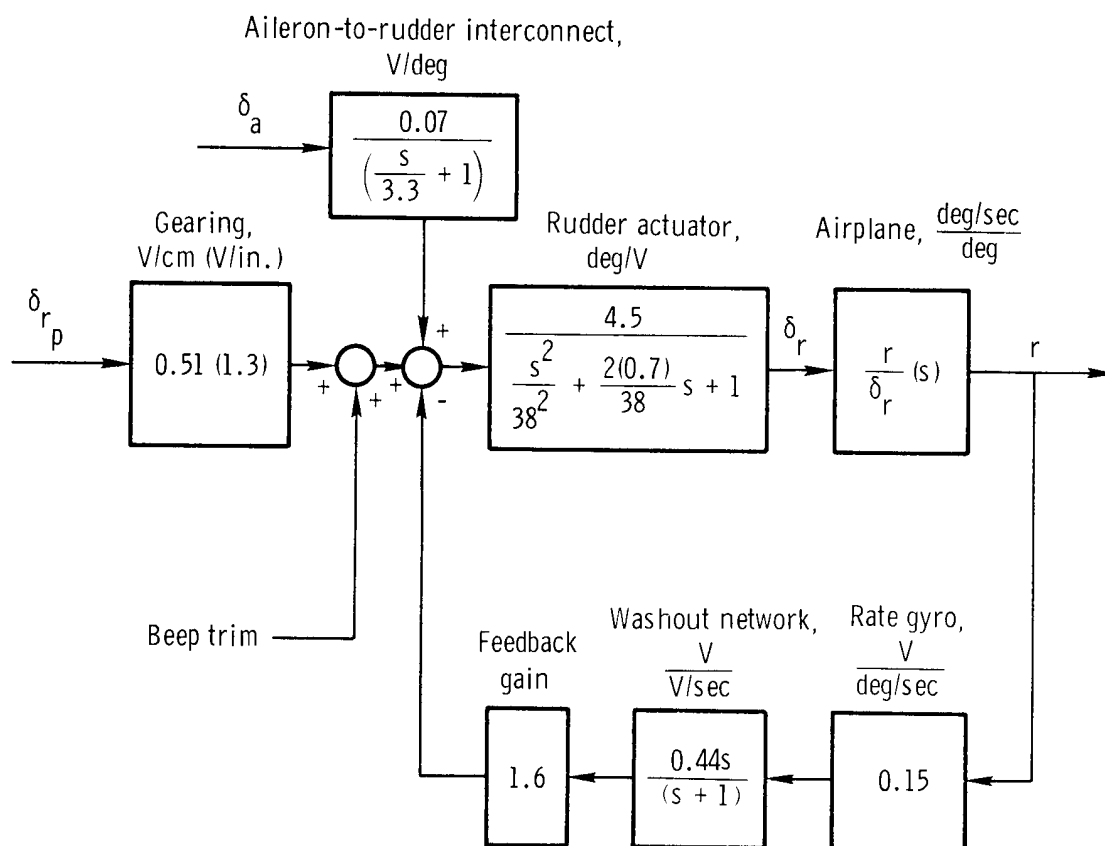
Figure 7. Yaw-rate damper and aileron-to-rudder interconnect.

The yaw axis was mechanized with a yaw-rate damper during the evaluation of the rate-command control system. Figure 7 shows a block diagram of the yaw damper system. An aileron-to-rudder interconnect was mechanized as part of the yaw damper to minimize adverse aileron yaw. The time constant of the lagged interconnect signal was matched to the adverse yaw characteristics of the airplane when flown at the approach speed of 100 knots (see ref. 5). A washout network in the system eliminated actuator responses to steady-state yaw rate during constant rate turns. The yaw-rate damper increased the airplane's Dutch-roll damping ratio in the approach configuration from 0.1 to approximately 0.7.

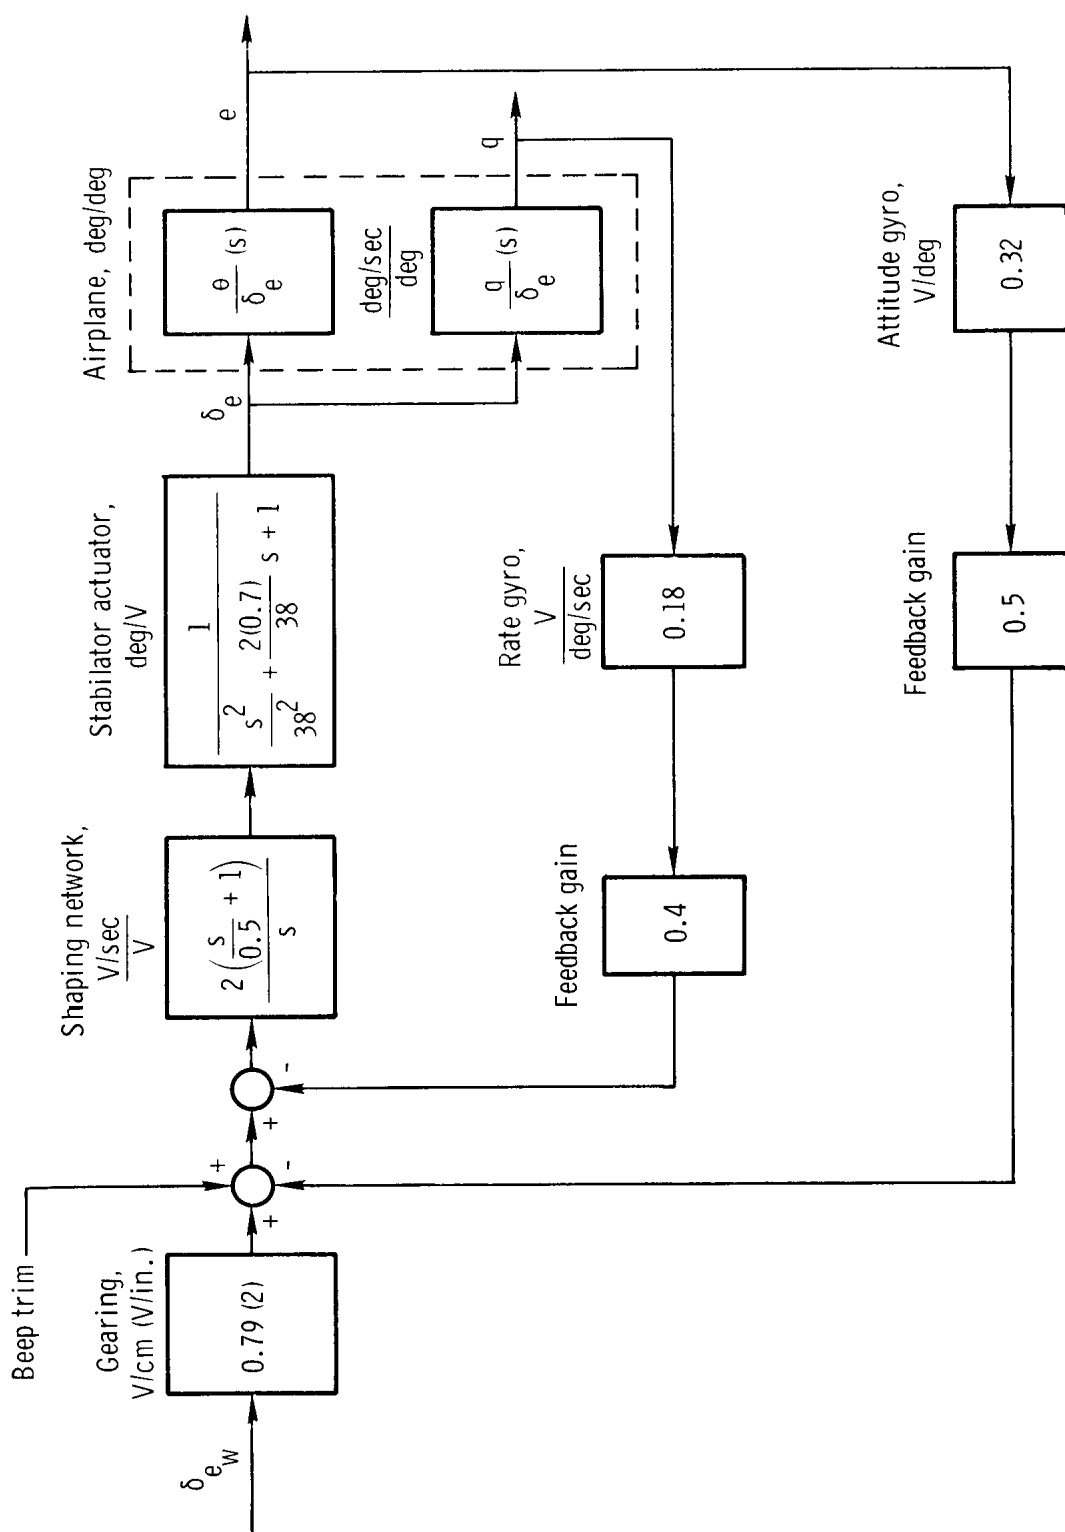
Figure 8. Pitch-attitude-command control system.

Figure 8 shows a block diagram of the pitch-attitude-command control system showing the shaping characteristics and feedback gains used during the instrument approach evaluations. When the pitch-attitude loop was closed, the pitch-rate inner loop provided short-period stability. The shaping network integrated the error signal, which resulted in the airplane's pitch attitude equaling the commanded pitch attitude. The lead term in the shaping network damped the highly oscillatory longitudinal phugoid mode, tightening pitch-attitude control.

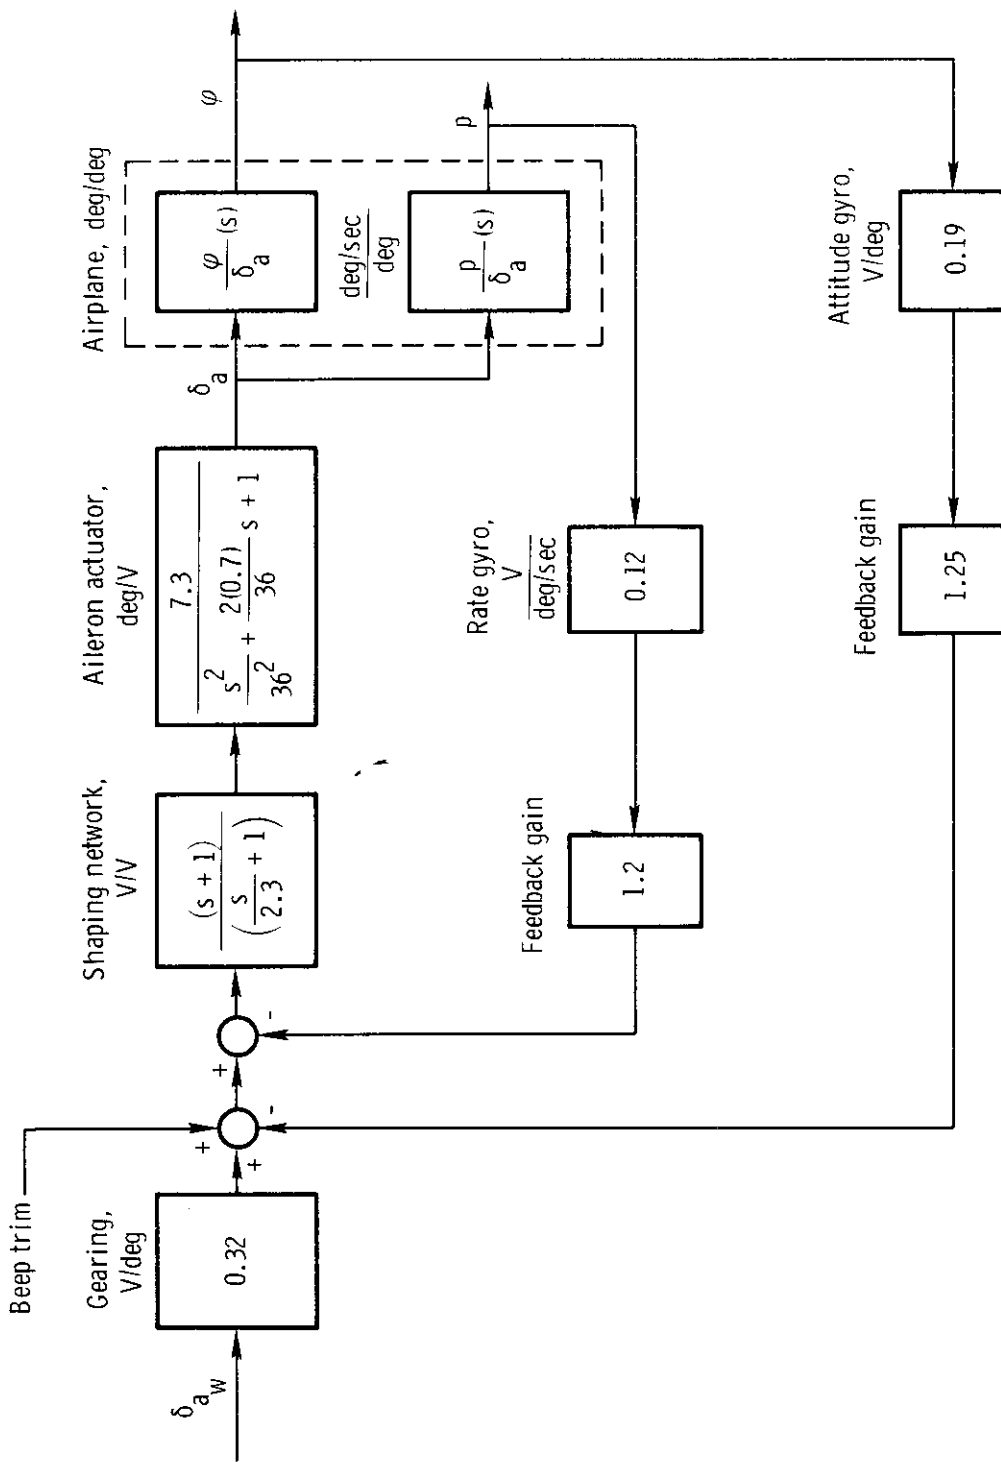
Figure 9. Roll-attitude-command control system .

Figure 9 shows a block diagram of the roll-attitude-command control system. Roll-rate feedback was mechanized as an inner loop that was similar to the inner loop in the pitch-axis mechanization. The use of roll-rate feedback increased the loop's sensitivity, which allowed the roll-attitude loop gains to be much smaller. Unlike the systems previously discussed, no integrating network was mechanized in the forward loop. The divergent spiral mode of the airplane, which had a very long time constant, was utilized as the error signal integrating device in the forward loop, and the mechanization of the system was therefore less complex. The shaping network provided closed-loop positive spiral stability. The dominant closed-loop roll response, which was second order, had a natural frequency of approximately 1 hertz and a damping ratio of 0.7.

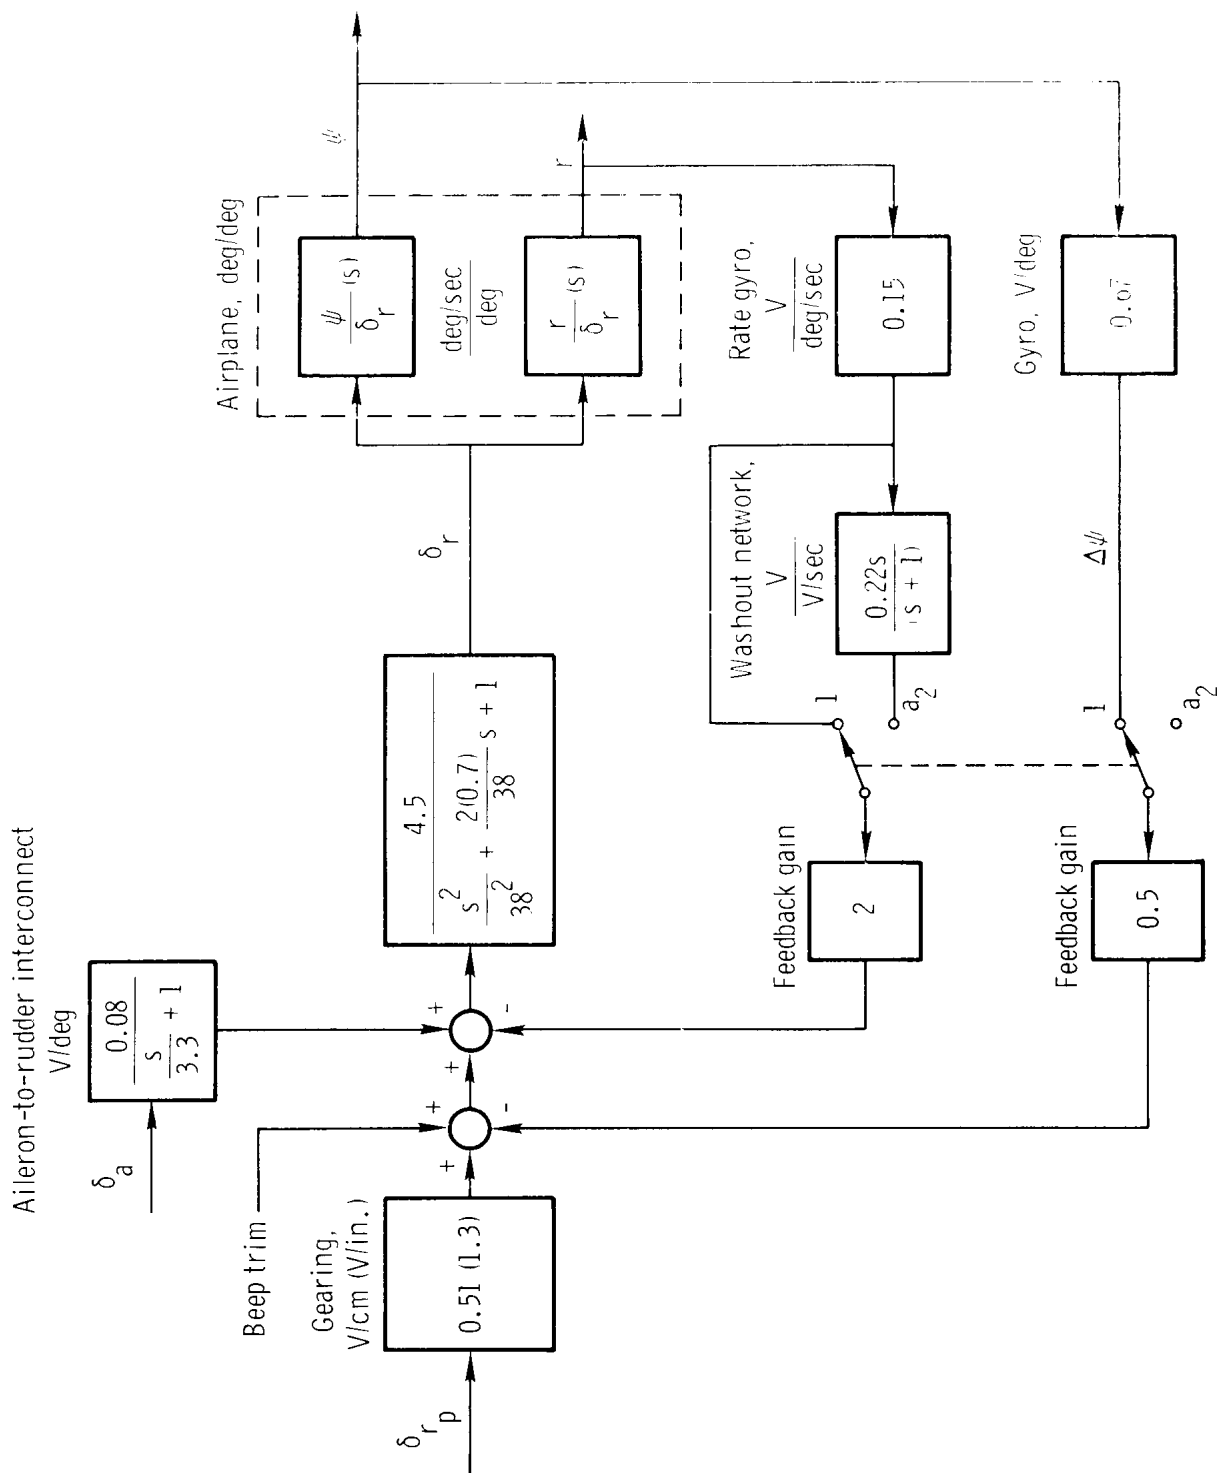
^aPosition 2 when $|\phi| \geq 3^\circ$ or beep trim on or both.

Figure 10. Yaw-heading-hold system.

Figure 10 shows a block diagram of the heading-hold mode mechanized in the yaw axis. The system was designed to maintain constant heading during level flight by mechanizing yaw rate and heading angle as feedback parameters to the rudder actuator. Yaw-rate feedback attenuated the Dutch-roll oscillation and increased the Dutch-roll damping to approximately 0.7. The heading-angle feedback loop opened when roll angle equaled or exceeded $\pm 3^\circ$ to permit turns. At the same time that the heading-angle loop opened, washed-out yaw rate was fed back to eliminate actuator responses during constant rate turns. An aileron-to-rudder interconnect was mechanized to eliminate high adverse aileron yaw as the pilot rolled into and out of the turn. The heading-hold loop also opened when the pilot activated the yaw beep trim. This allowed the pilot to trim sideslip with the wings level after a new heading was established. Moving the rudder pedals 0.64 centimeter (0.25 inch) or more also opened the heading loop. However, the pilots observed that they never needed to use the rudder pedals because the aileron-to-rudder interconnect provided coordination during turns.

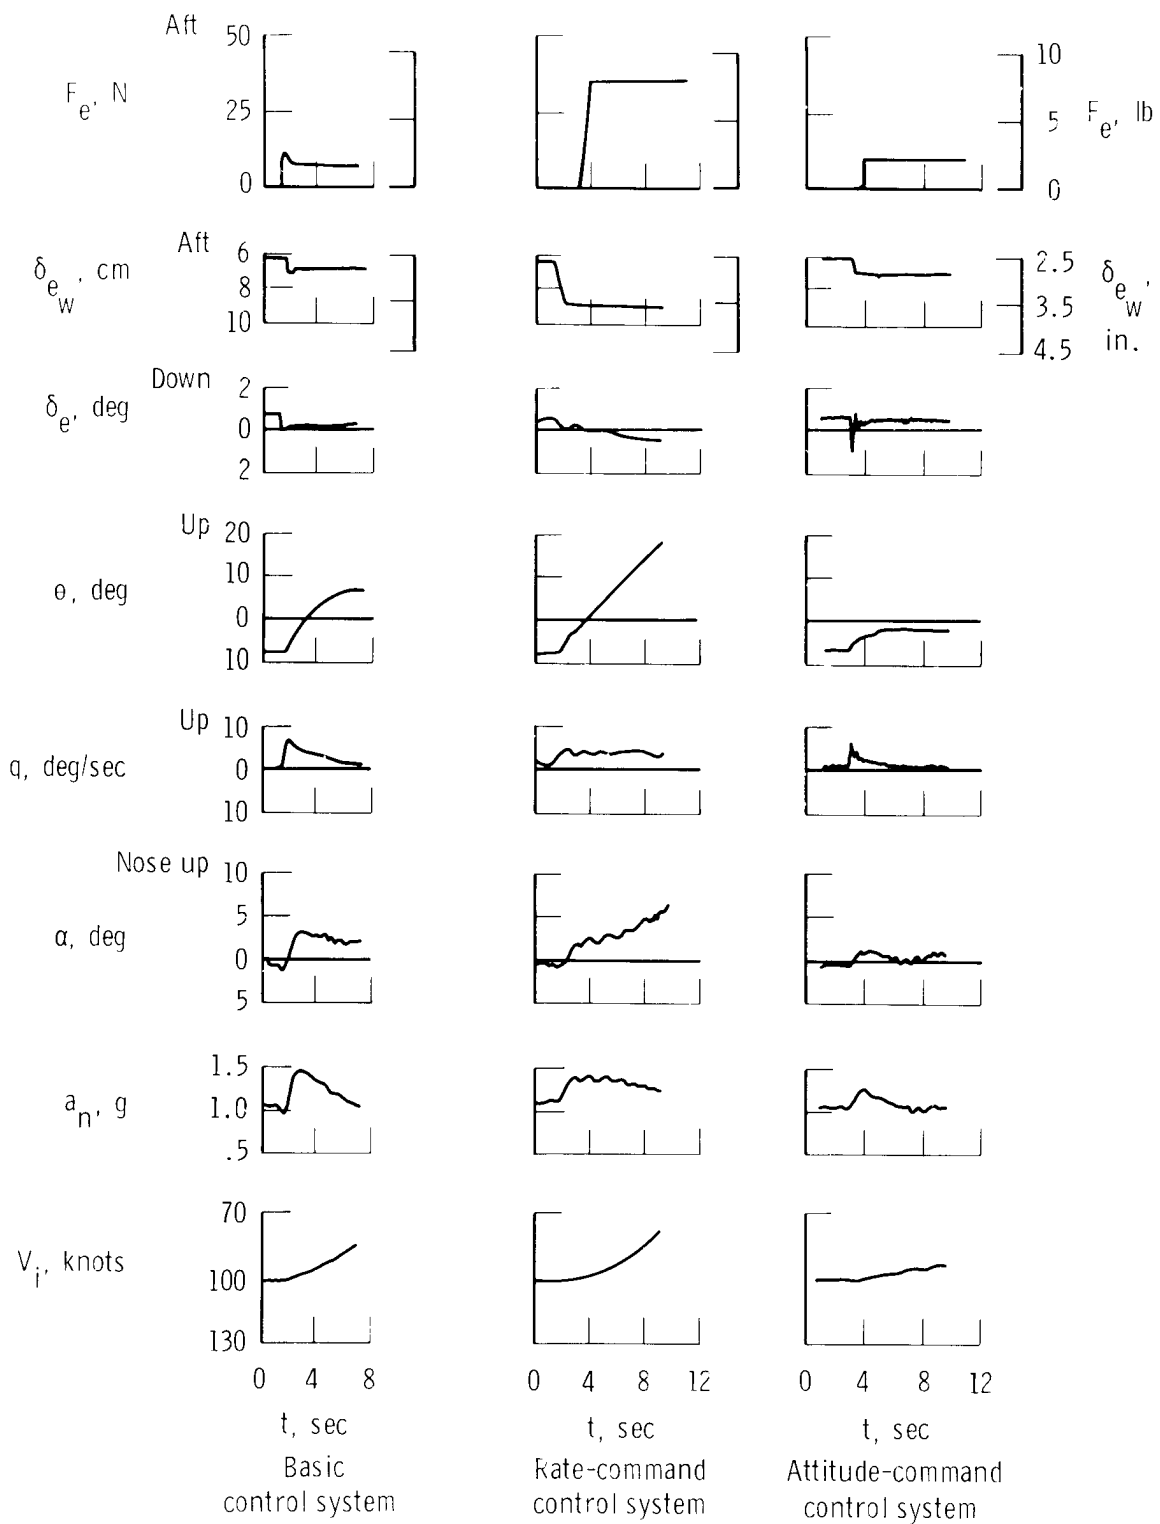
(a) Longitudinal response.

Figure 11. Effect of control systems on response of test airplane to step input. $V_i = 100$ knots; $\delta_f = 27^\circ$; gear down.

Longitudinal response: Figure 11(a) shows time histories of pitch angle, pitch rate, angle of attack, normal acceleration at the center of gravity, and stabilator response to a pilot control step input. With the basic control system, the step input was followed by an essentially constant angle-of-attack response and varying pitch angle, pitch rate, and normal acceleration. The control surface followed the pilot control input. The airplane tended to maintain elevated g until speed reduction

With the rate-command control system, the step input produced a constant pitch-rate response and varying pitch angle, angle of attack, and normal acceleration. The system commanded the control surface at a constant rate to maintain constant pitch rate. The airplane tended to maintain a constant pitch rate as long as the command was present, and angle of attack increased until either the airplane stalled or the command was removed.

With the attitude-command control system, a step input produced constant pitch angle and variations in pitch rate, angle of attack, and normal acceleration. The control-surface response was rapid and quickly established a constant pitch attitude. Normal acceleration increased until the pitch angle stabilized. From then on, the airplane either climbed or dived, depending on the command, in trimmed 1g flight. Airspeed varied until the airplane stabilized on a new trim speed. Therefore, except for throttle changes, the attitude-command control system essentially provided flight-path control.

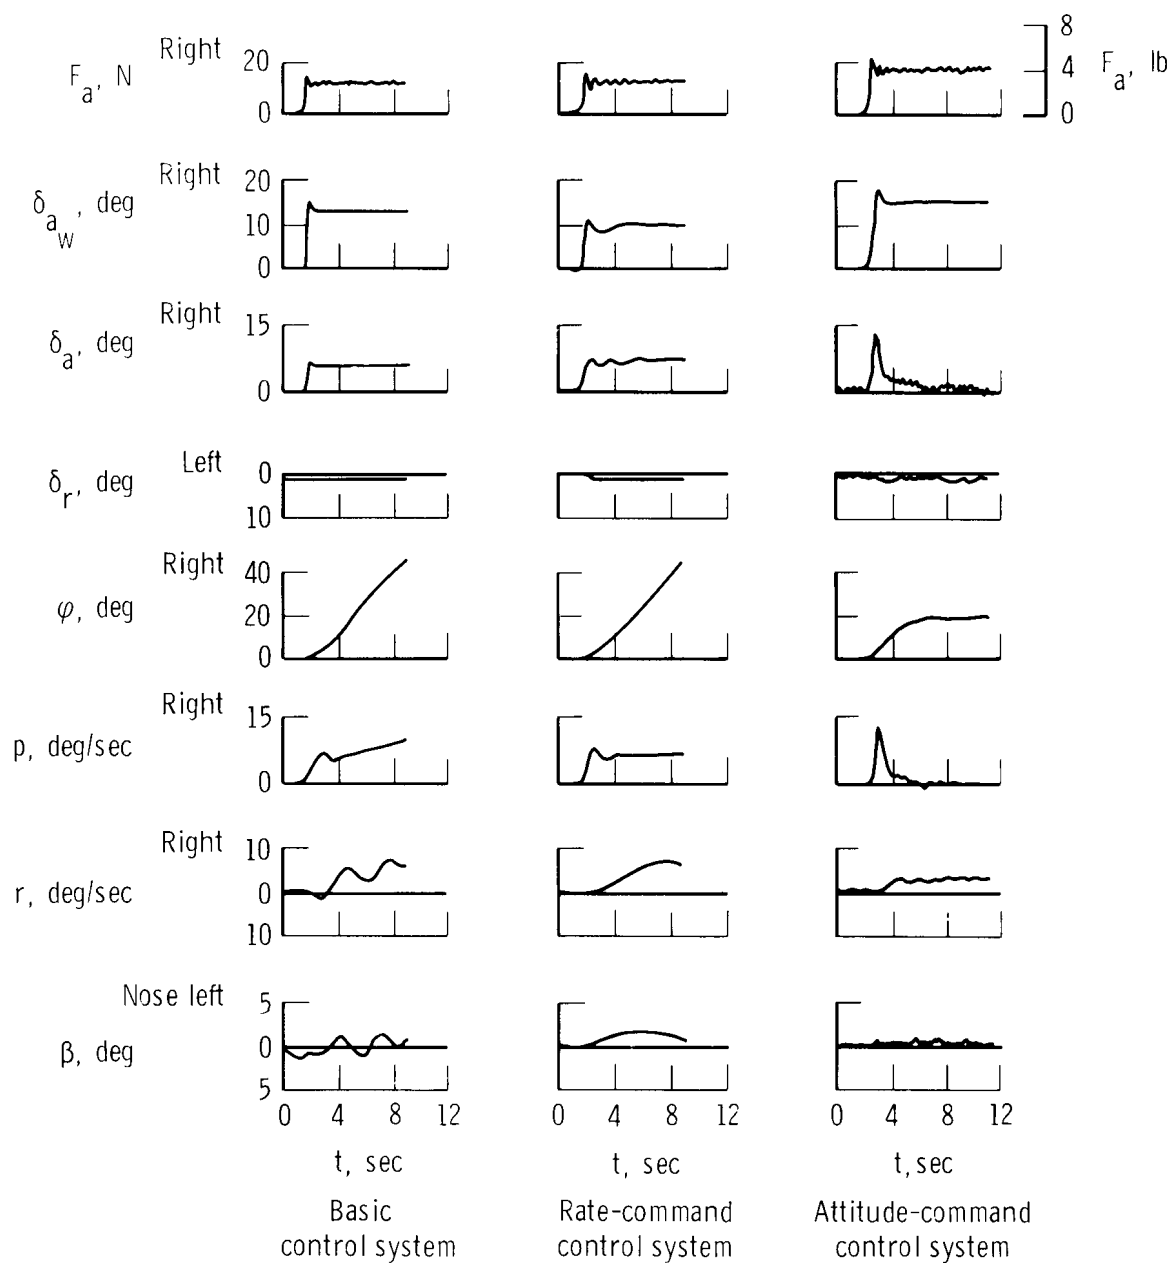
(b) Lateral-directional response.

Figure 11. Concluded.

Lateral-directional response: A comparison of the effects of the basic control system, the rate-command control system, and the attitude-command control system on the lateral-directional response of the airplane is shown in figure 11(b). Time histories of bank angle, roll rate, yaw rate, and sideslip angle after an aileron step command are shown.

With the basic control system, the step input produced a reasonably constant roll rate and varying bank-angle, yaw-rate, and sideslip responses. The light damping of the Dutch-roll oscillations and the adverse yaw are apparent in the yaw-rate and sideslip responses. The negative spiral stability of the airplane is illustrated by the slight divergence in the roll rate.

With the rate-command control system, the step input resulted in a constant roll-rate and varying roll-angle, yaw-rate, and sideslip responses. The system provided effective yaw damping and essentially eliminated the adverse aileron yaw, as shown by the yaw-rate and sideslip responses.

With the attitude-command control system, a step input produced a constant bank angle and varying roll-rate, yaw-rate, and sideslip responses. The airplane remained at the commanded roll attitude until the stick input was removed. The yaw damper attenuated the Dutch-roll oscillations associated with yaw rate, and the interconnect eliminated adverse yaw and minimized the sideslip response as the aircraft rolled into the turn.

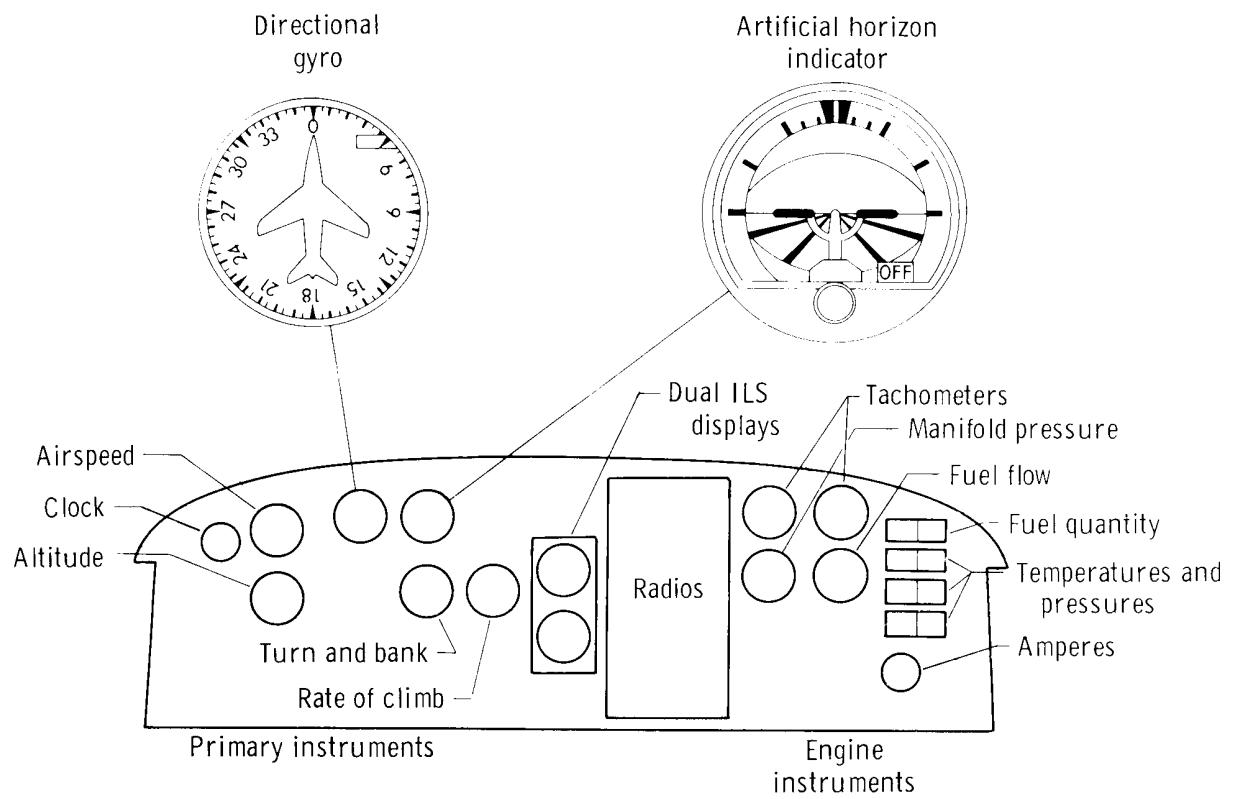
Figure 12. Basic instrument display .

Basic display.— Figure 12 shows the basic instrument display, which was used during the first phase of the program. ILS approaches were flown with the basic display and the basic control system, rate-command control system, and attitude-command control system. As the directional gyro and artificial horizon indicators

show, the instruments were typical of general aviation aircraft. The basic guidance display operated from a conventional radio receiver, and glide-slope and localizer error information were presented on a conventional cross-pointer indicator.

The pilots commented that to monitor the basic instrument display (fig. 12) they had to scan half the instrument panel. Furthermore, the engine performance instruments were on the other side of the cockpit. The head movement necessary to monitor them caused a significant time loss because the pilot's eyes had to refocus. Monitoring the ILS instruments in conjunction with the directional gyro was particularly difficult. In addition, the attitude indicator was difficult to interpret rapidly because of its lack of sensitivity, small size, and cluttered appearance. These deficiencies made the instruments impossible to monitor with peripheral vision.
